Flood Plain Development Application/Permit

GRAIN PROCESSING CORP.
 FEED BARGE
 CELL REPLACEMENT
 DATE: 11/15/2018
 LOCATION: MUSCATINE, IA
 RIVER MILE 453.74

Underwater Inspection Report

Structure: Dock Cells

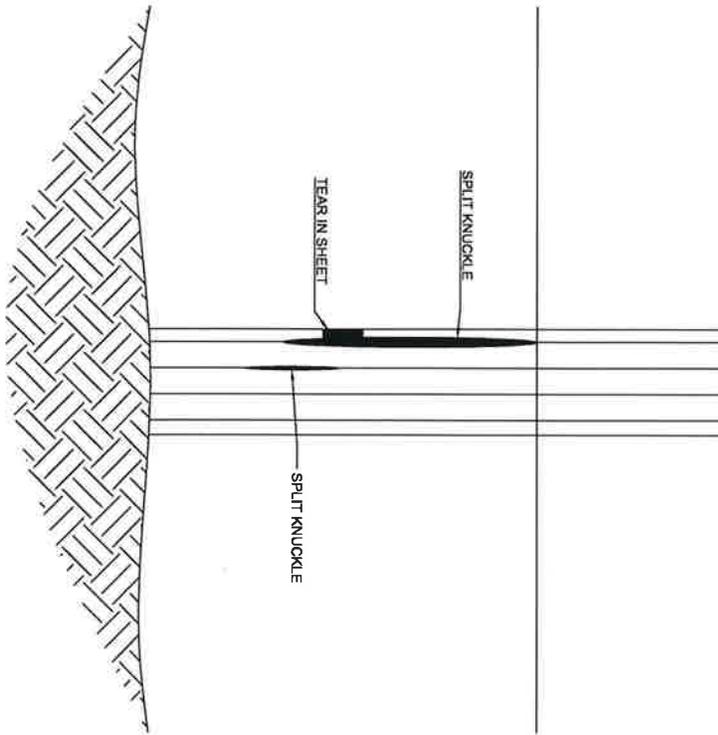
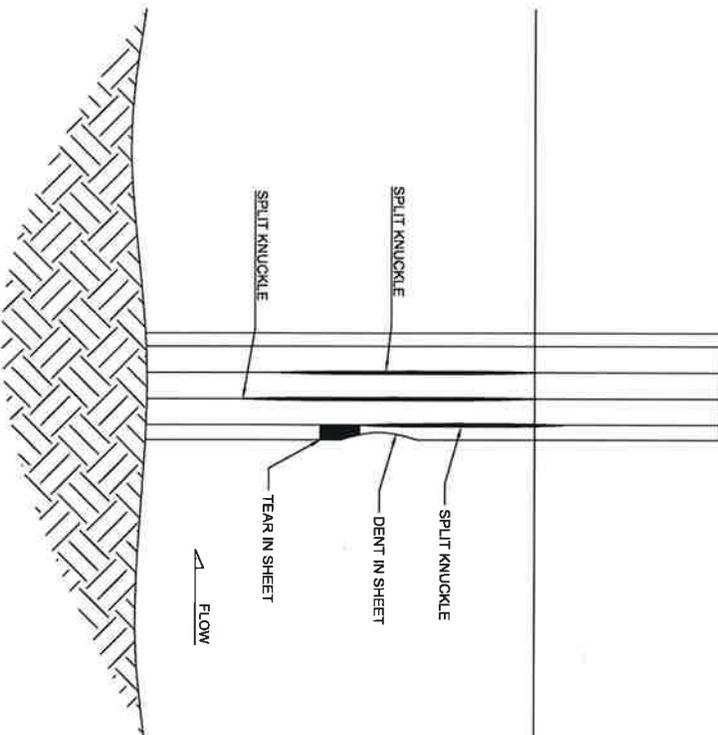
FIGURE NUMBER
A-2

- The cell had significant backfill loss inside the cell. The material had been carried away by the river flow with no buildup of material at the base of the structure.

- At the midpoint of the East face the knuckle was starting to split. The spit ran vertically from approximately 7 feet above the sediment line to approximately the waterline. There was no gap between the knuckles.

- The next knuckle upstream had a split that started approximately 5 feet above the mudline and extended approximately to the waterline. The split had a gap up to ½ inch between the knuckles.

- The next sheet upstream had significant damage from an apparent impact. The damaged started 9 feet above the sediment line, the sheet was ripped out creating a void 1 foot wide by 2 feet tall. The knuckle above the void was split 1 inch wide and extended 11 feet up to the waterline and extended 1.5 feet above the waterline.

- On upstream face and the first knuckle from the East corner there was a split in the sheet. The split started approximately 7 feet above the sediment line and extended to the waterline. The split had a gap up to 6 inches wide.

- Three sheets West of the Northeast corner the sheet had a dent. The dent was approximately 12 feet above the sediment line and was approximately 3 feet tall. The dent was pushed in 1 foot and extended to the Northeast corner.

- On the upstream face the second knuckle from the Northeast corner has a split that starts 5 feet above the mudline. The split extends up 7 feet to the dent. The split knuckle has a gap of approximately ¼ inches wide.

- The Northeast corner of the cell is dented and has a 6 foot long crack that starts 8 inches above the waterline. The crack is up to 1/4 inch wide.
- The general condition of the sheets

- From the sediment line and extended 10 feet up the sheets had 80% surface corrosion.
 - From 10 feet above the sediment line to the waterline had 40% surface corrosion.

Based on the underwater inspection findings at the time of inspection, the Dock Cells were considered to be in Poor condition. The downstream cluster had significant damage to the Northeast corner and heavy fill loss from inside the cell. The downstream cluster was noticeably weakened and should be repaired or replaced. The upstream cell had moderate deterioration with splits and cracks which have allowed some fill loss. The splits and cracks of the upstream cell should be repaired to stop deterioration of the structure and backfill loss.

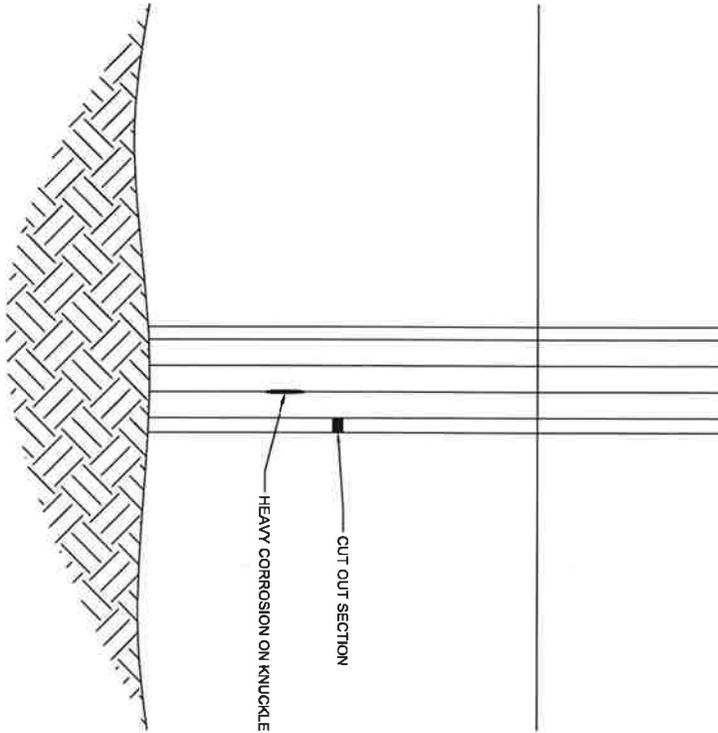
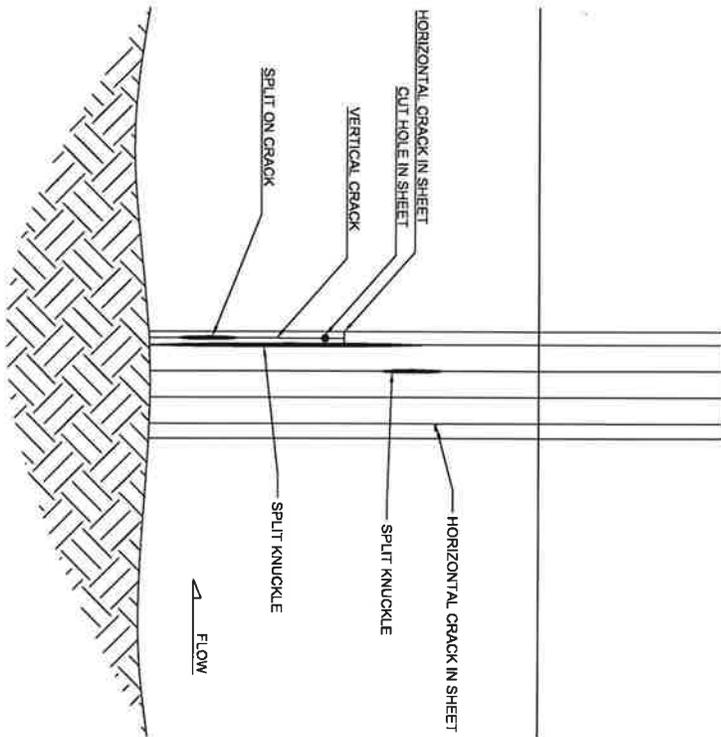
FORM NUMBER
A-3

- The cell had significant backfill loss inside the cell. The material had been carried away by the river flow with no buildup of material at the base of the structure.

- At the midpoint of the East face the knuckle was starting to split. The spit ran vertically from approximately 7 feet above the sediment line to approximately the waterline. There was no gap between the knuckles.

- At the Southeast corner and approximately 10 feet above the mudline there was a 1 foot long horizontal crack. At the corner a vertical crack extended down from the horizontal crack. The vertical crack ran down to the mudline and through a 2-3/4 inch hole in the sheet. The crack was ¼ inch wide for the majority of the length. Near the bottom of the crack there was a 1 foot section that the crack was up to 2 inches wide.

- A split knuckle was found on the East face of the cell and just upstream of the downstream corner. The split starts approximately 6 feet below the waterline. The split was 14 feet long and up to 1-1/2 inch wide.

- A split knuckle was found on the East face of the cell and was the second knuckle from the Southeast corner. The split started approximately 5 feet below the waterline. The split was 3 feet long and up to ¼ inch wide.

- A crack was found on the East face of the cell and the first knuckle down from the Northeast corner. The horizontal crack was approximately 5 feet below the waterline. The crack was 6 inches wide and up to 1/8 inch wide.

- A knuckle with heavy corrosion was found on the upstream face and was the second knuckle from the Northwest corner. The area of heavy corrosion was located approximately 12 feet below the waterline. The area of heavy corrosion with noticeable section loss on the knuckle was approximately 2 feet tall.

- An area of removed sheeting was found at the Northwest corner and on the upstream sheet. The area of removed sheeting was approximately 10 feet below the waterline and was 6 inches high by 1 foot wide. The area appeared to have been cut out and had an open void.
