City Administrator Report to Mayor & City Council

Report of the Papoose Force Main Emergency Repair 2017-2018

Summary of Force Main Repair October 2017-February 2018

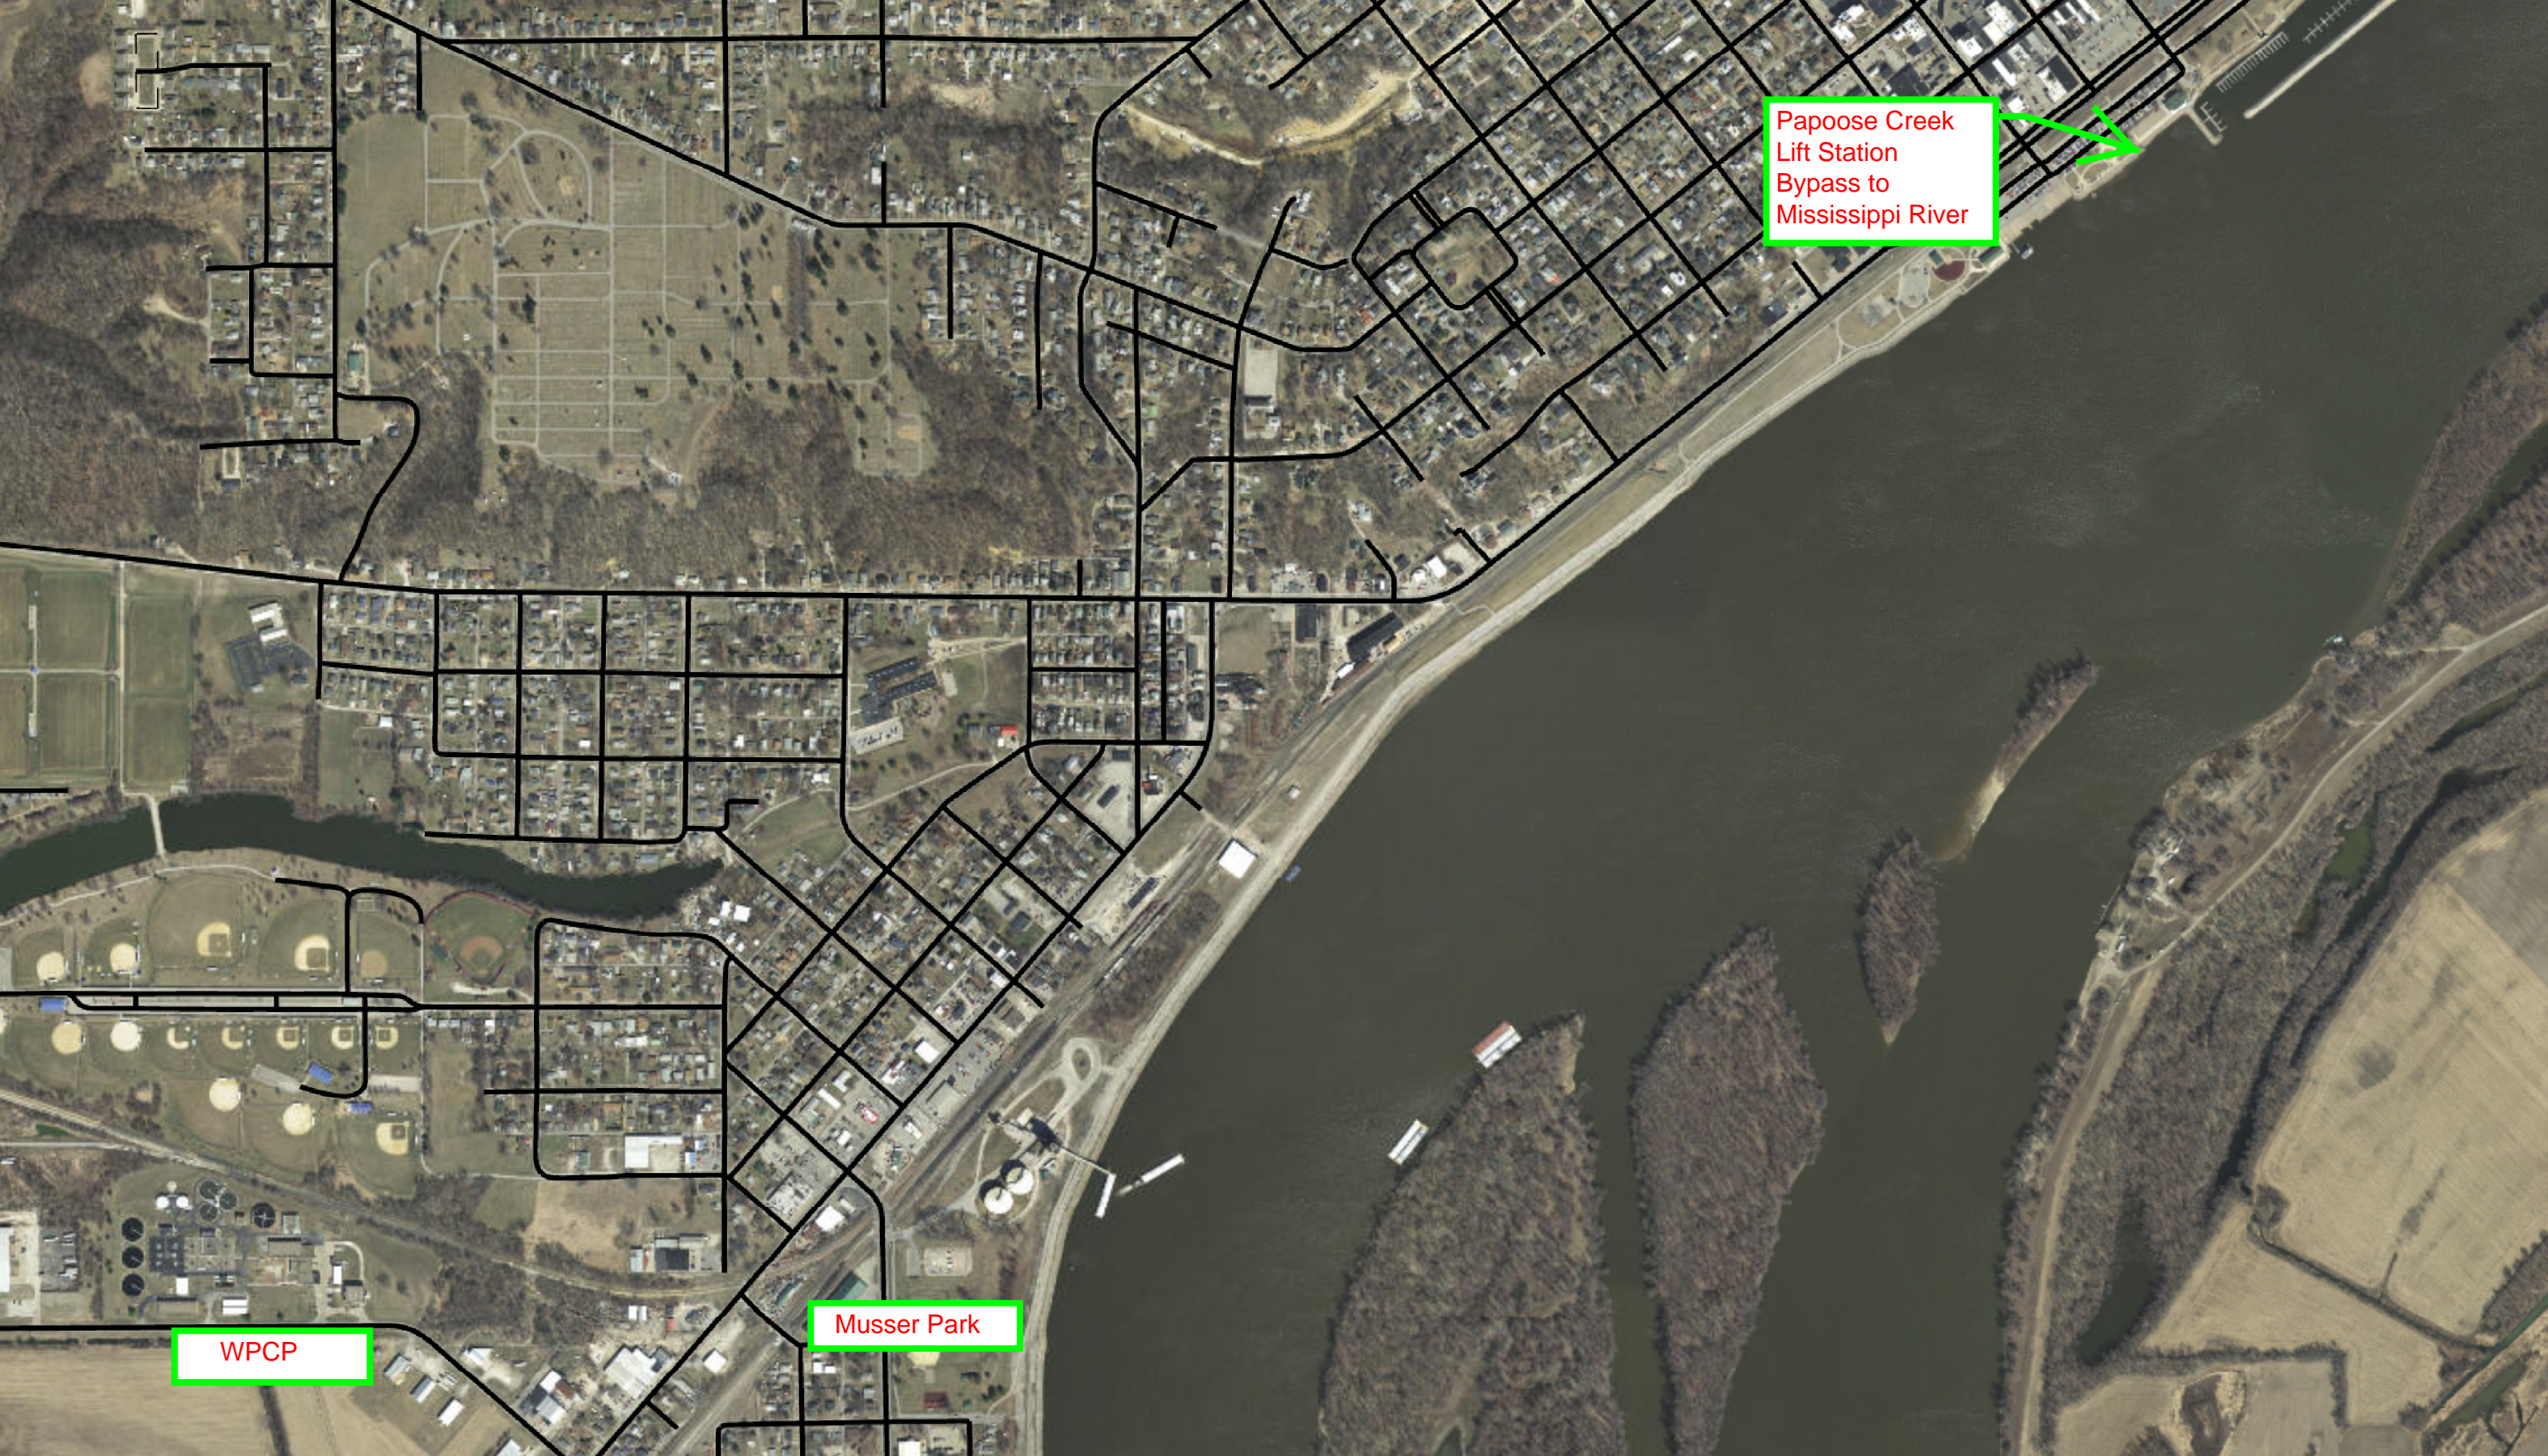
Papoose Creek
Lift Station
Bypass to
Mississippi River

Musser Park

WPCP

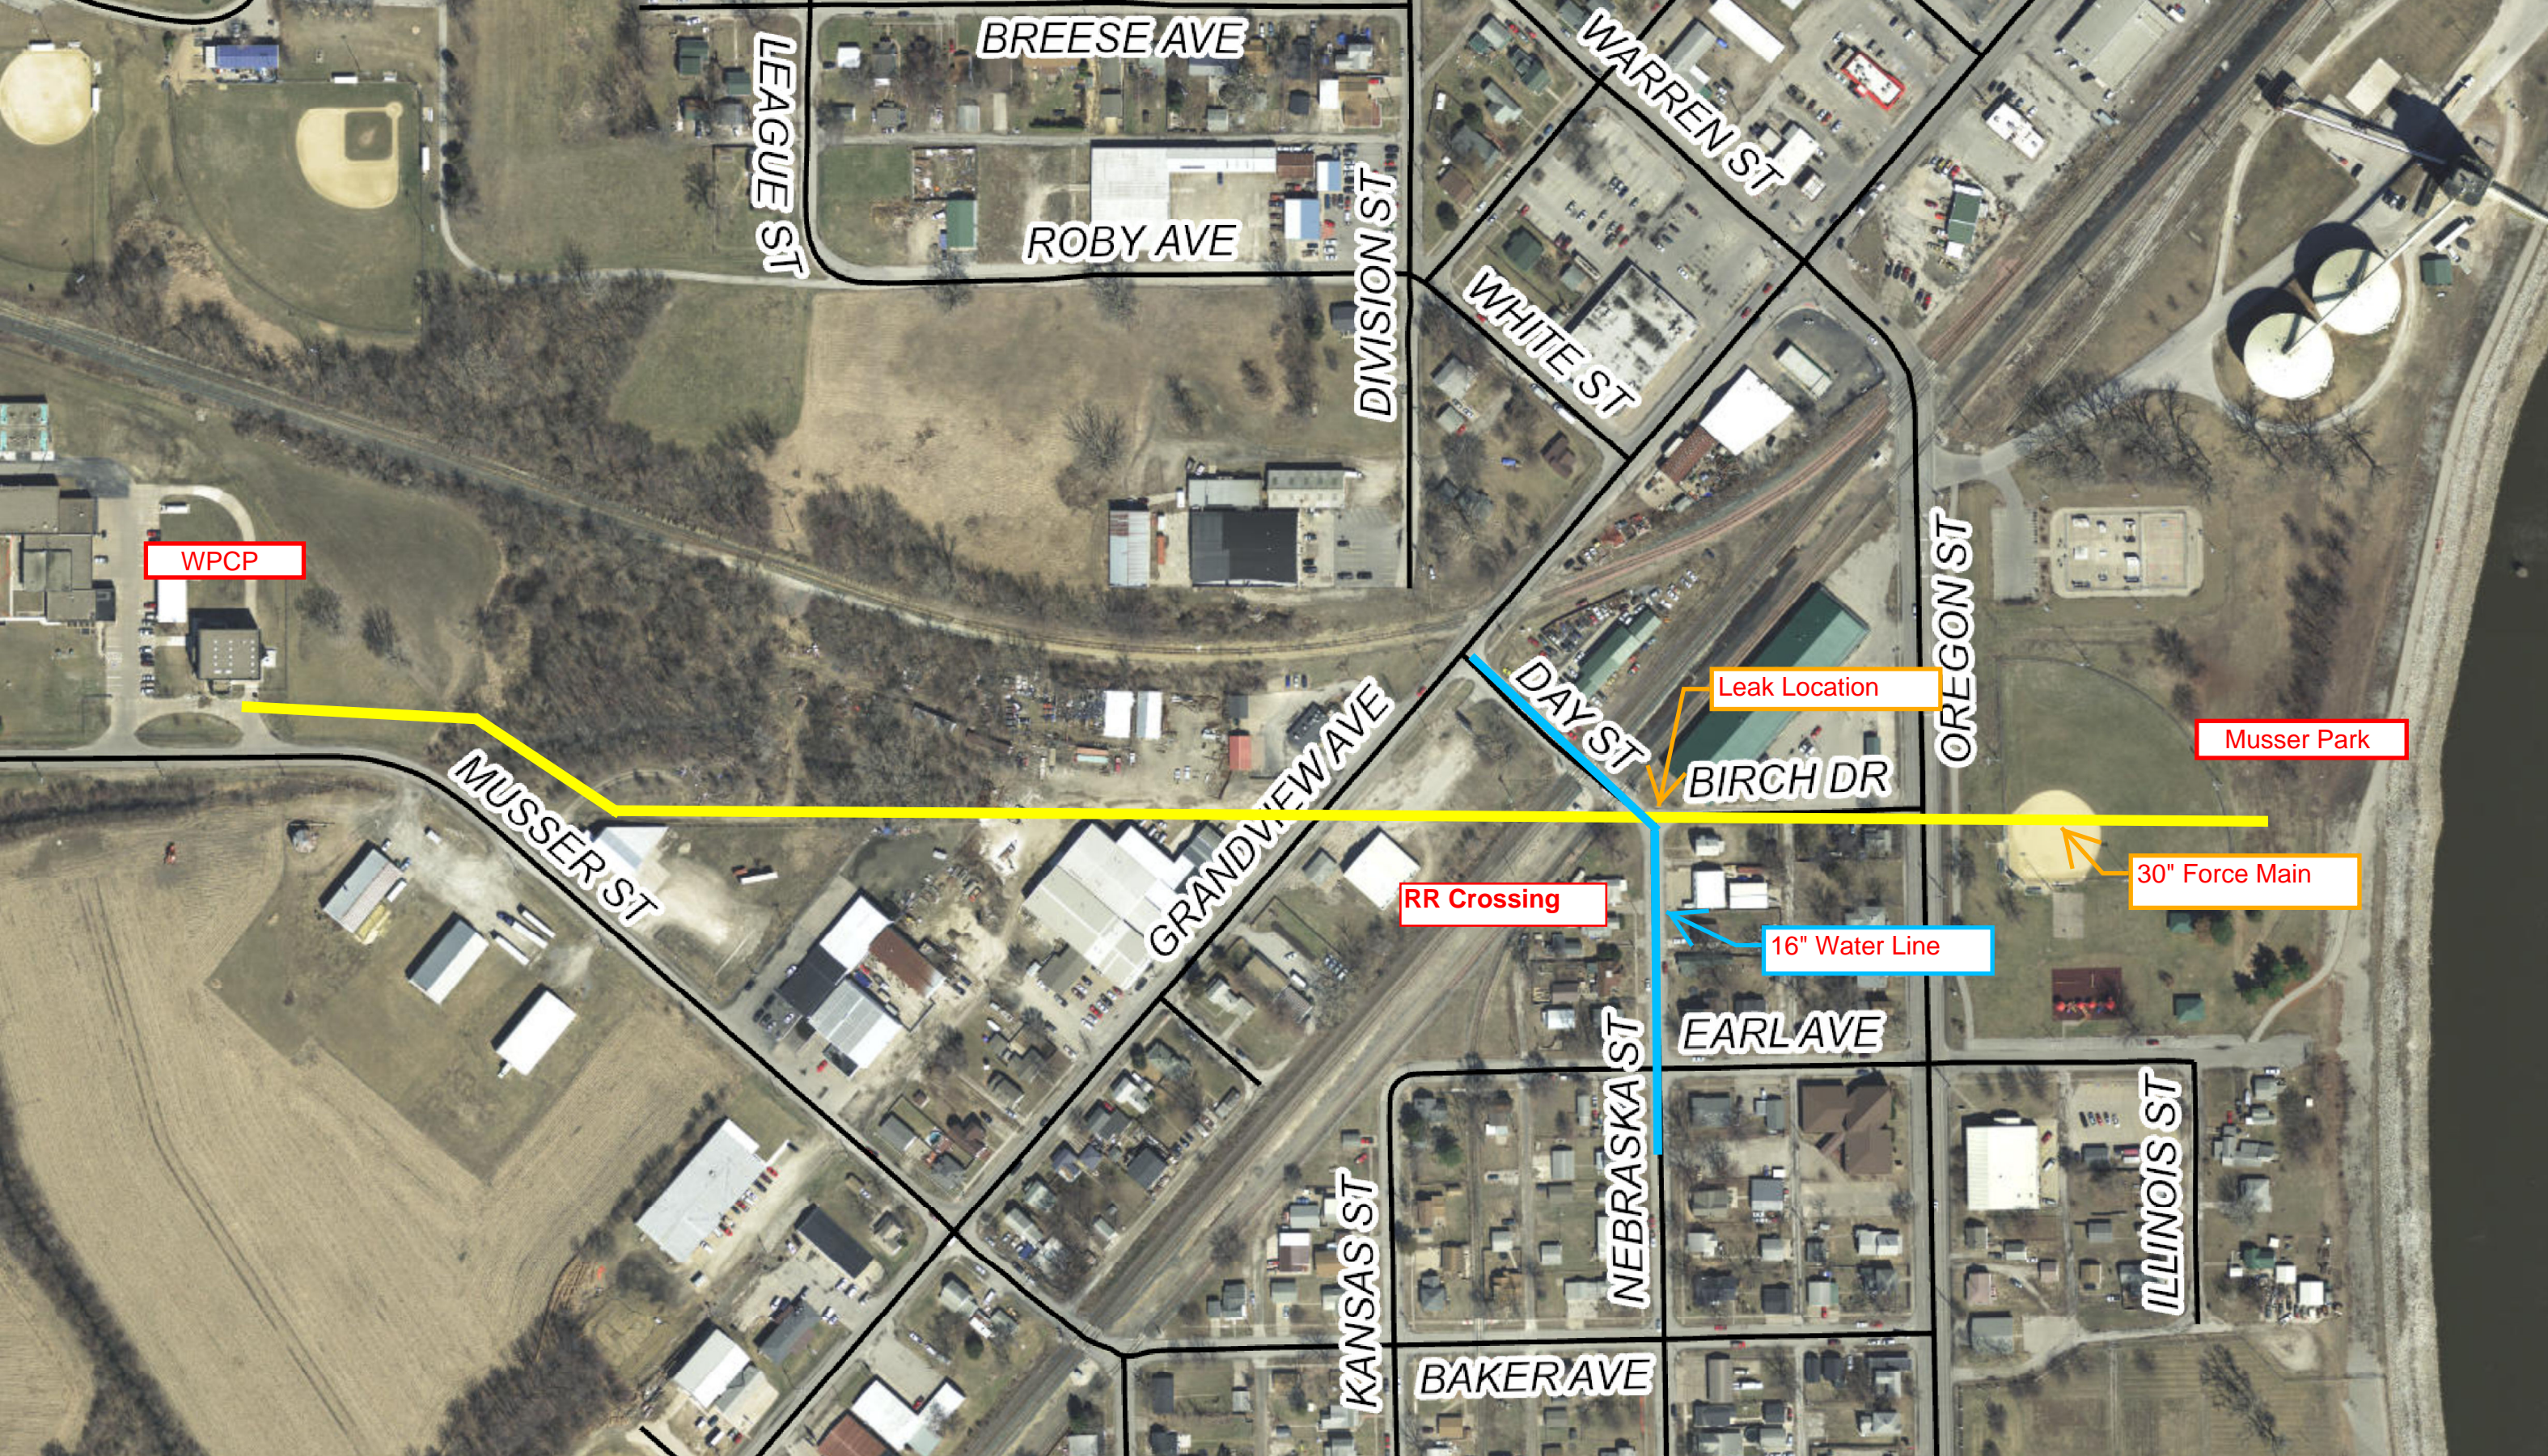
Leak Location

Musser Park

30" Force Main

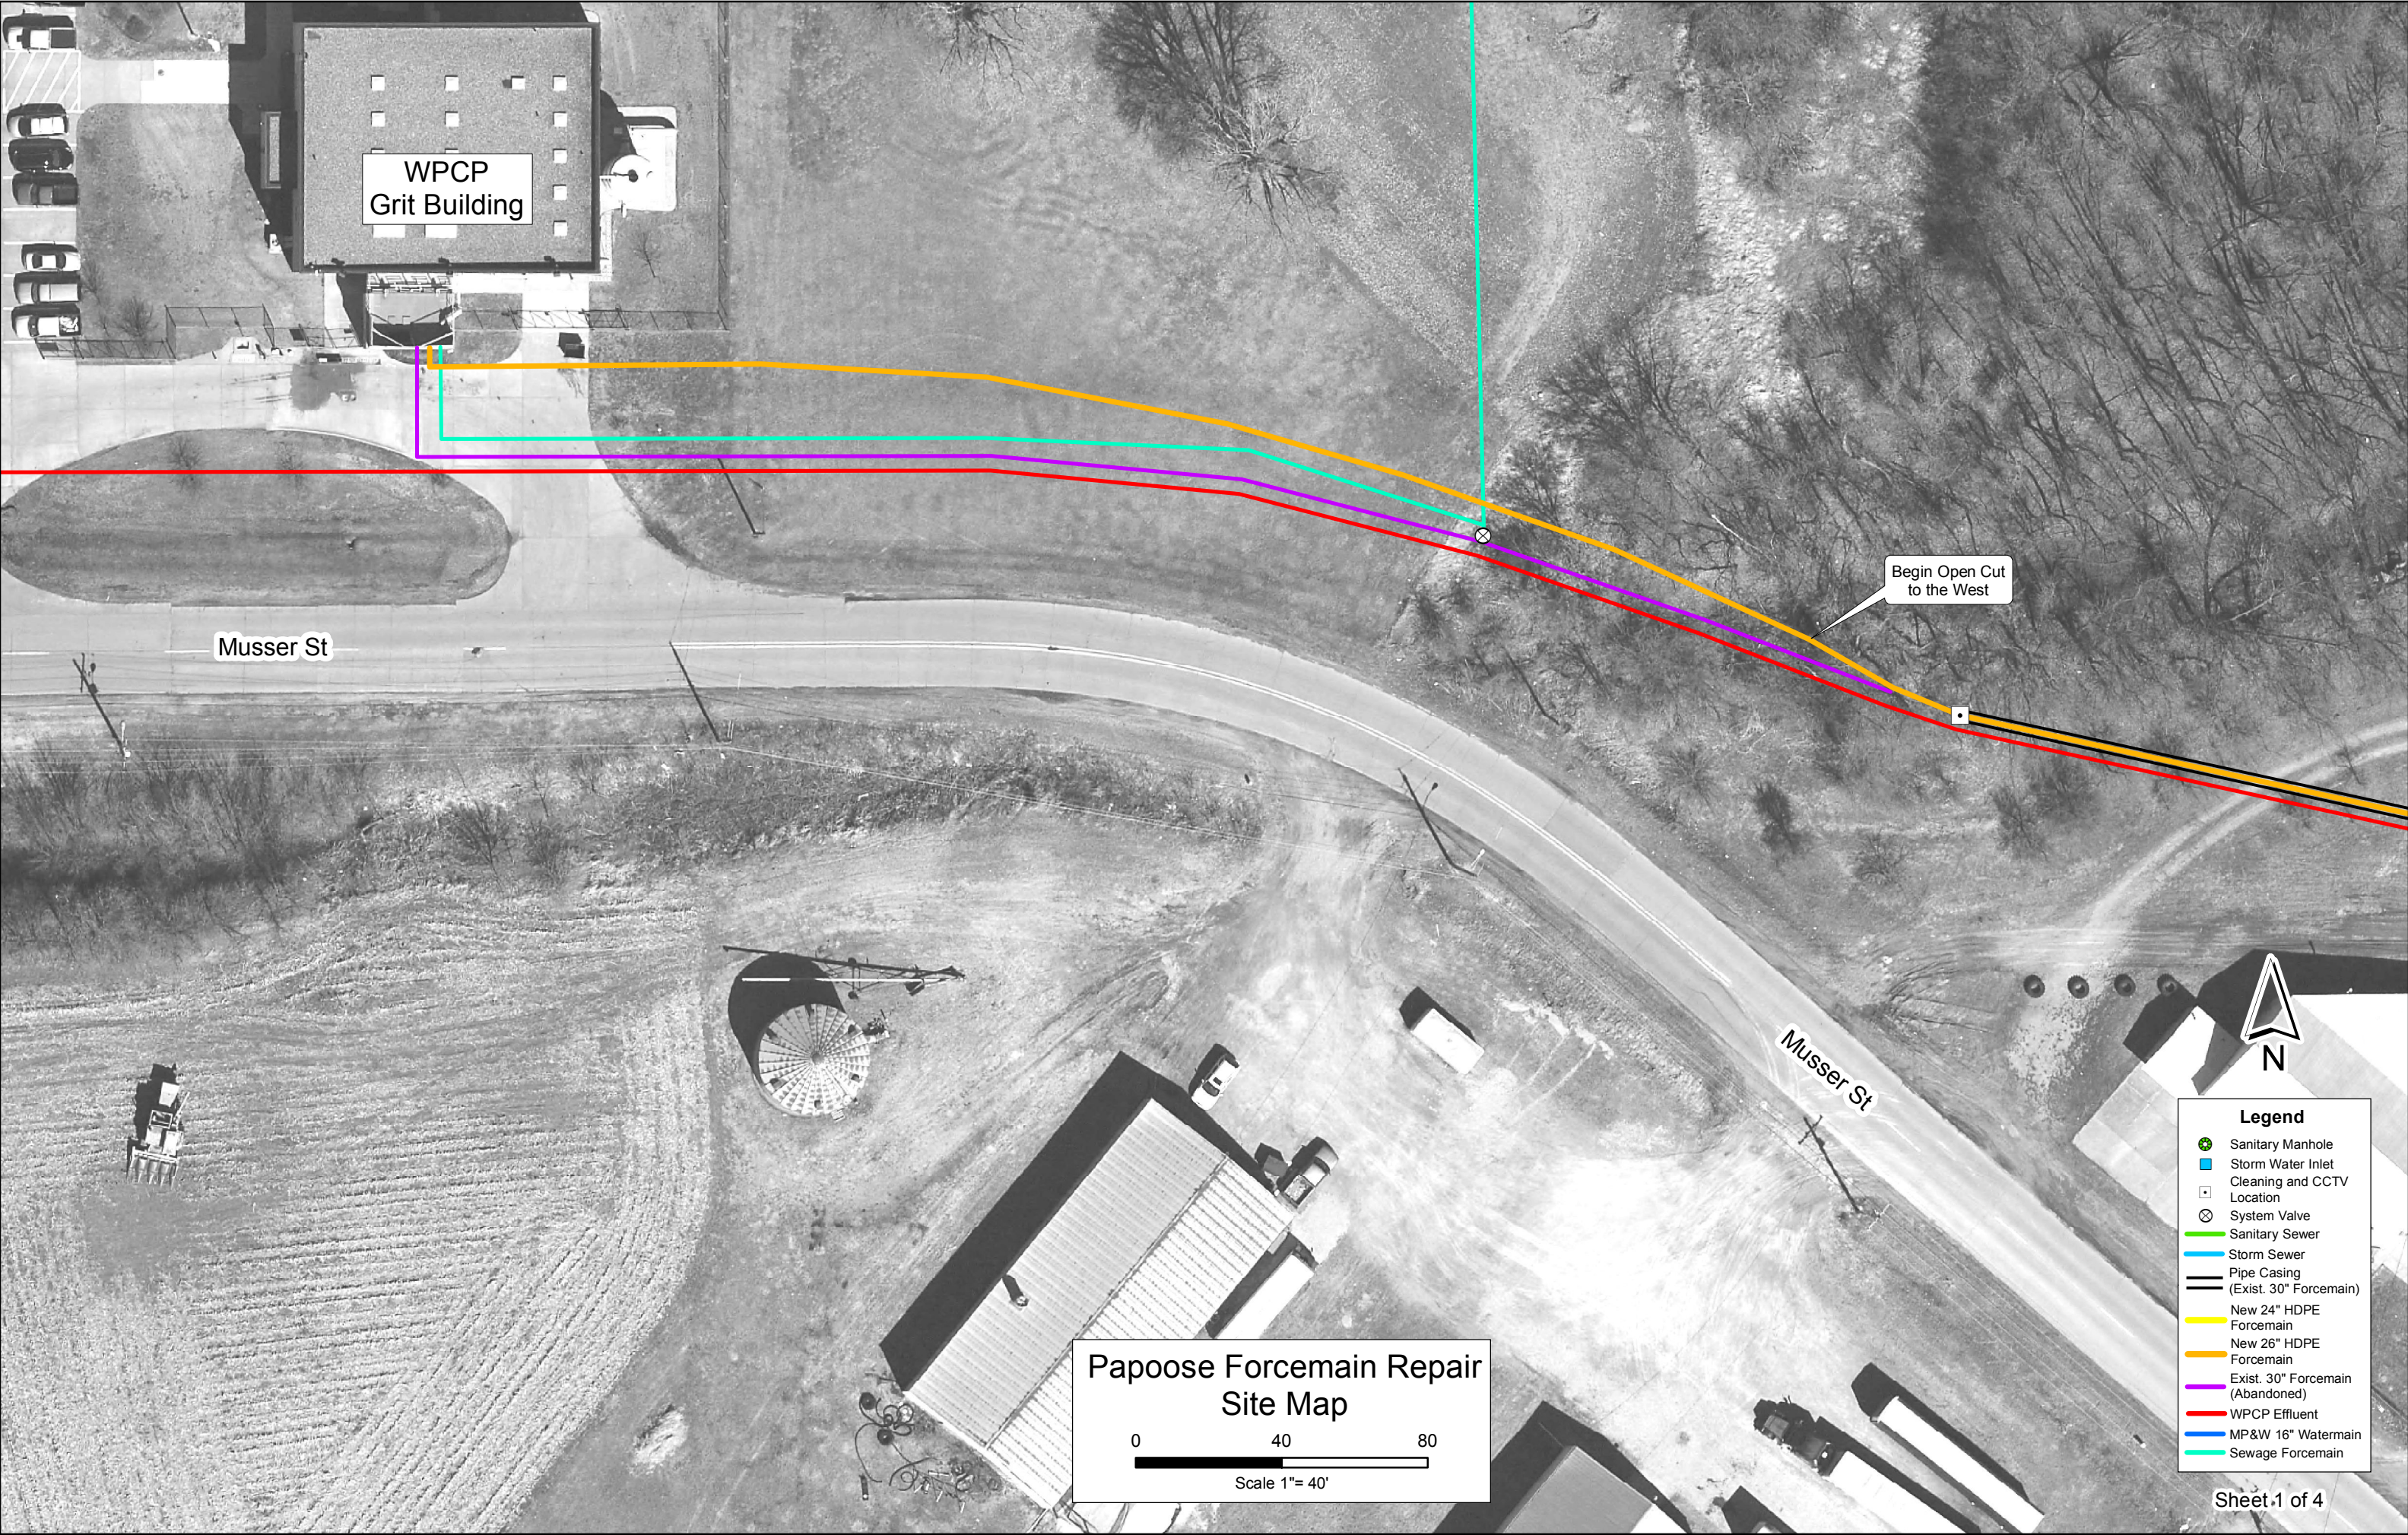
Papoose Forcemain Repair
Site Map

WPCP
Grit Building

Musser St

Scale 1"= 40'

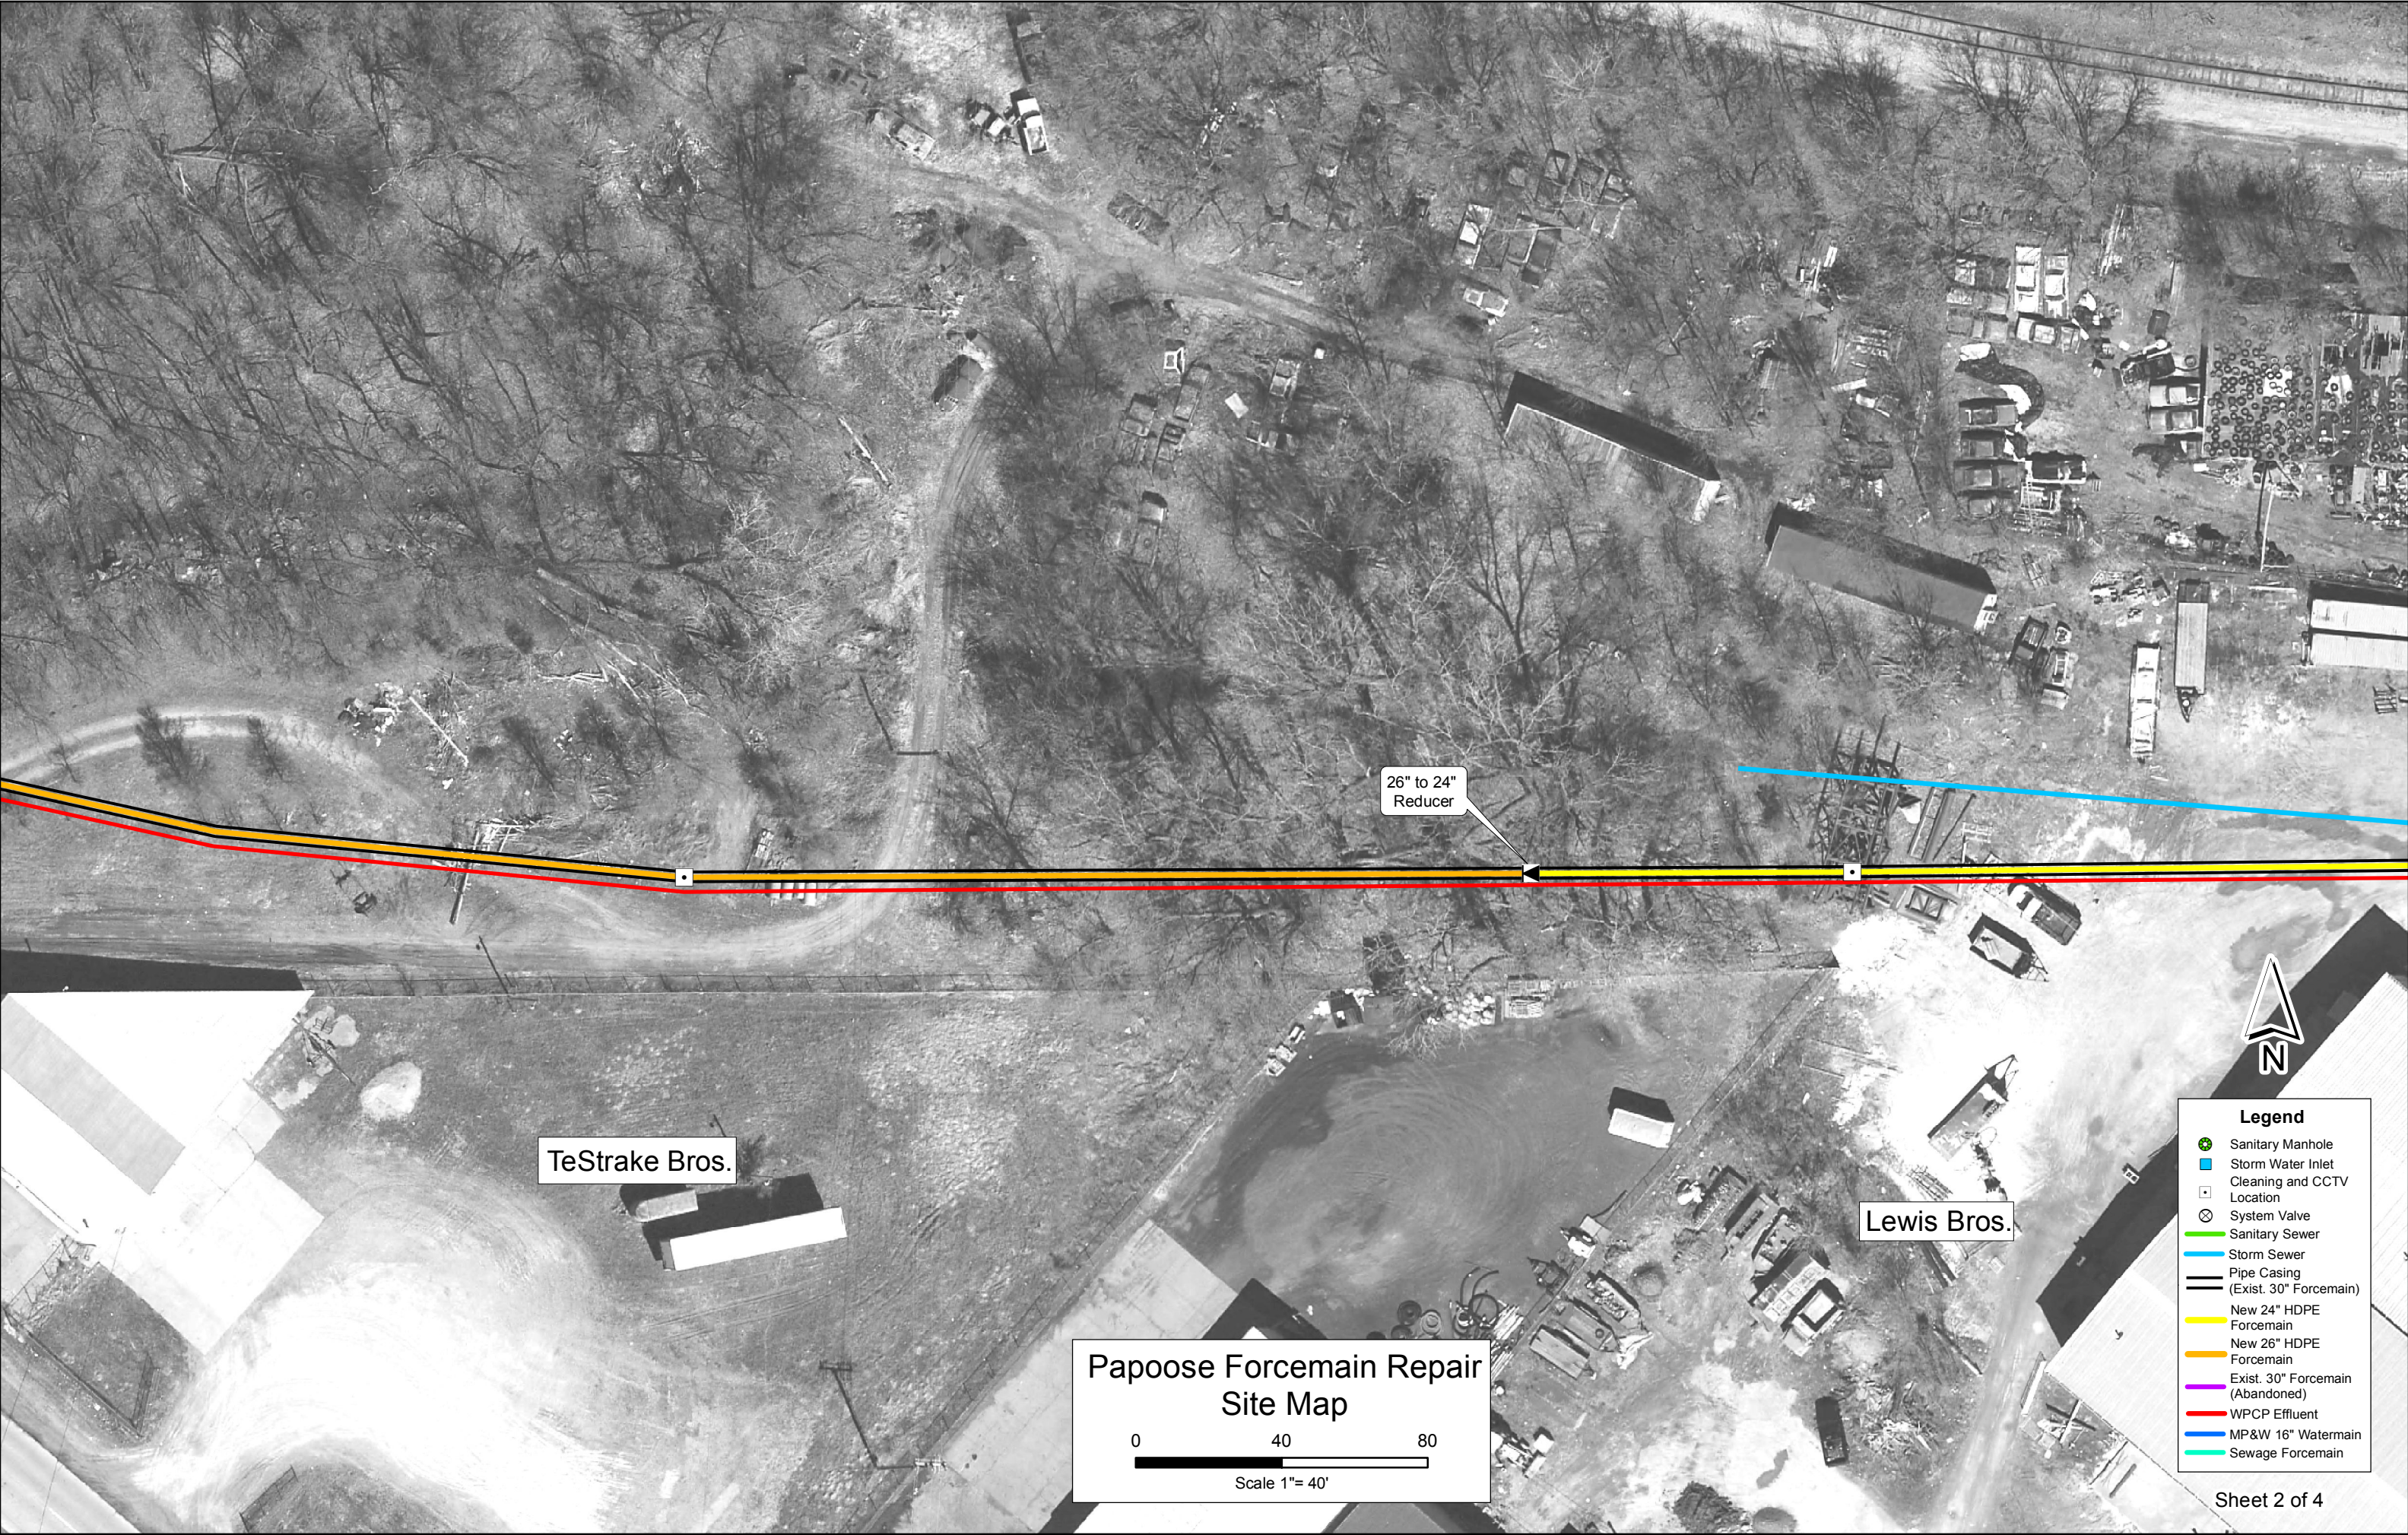
Papoose Forcemain Repair
Site Map

26" to 24"
Reducer

TeStrake Bros.
