CITY OF MUSCATINE PRESS RELEASE

GOOD NEWS! NEW FORCE MAIN PIPE IS NOT LEAKING

Backflow into abandoned force main and found a way out 500 feet from WPCP

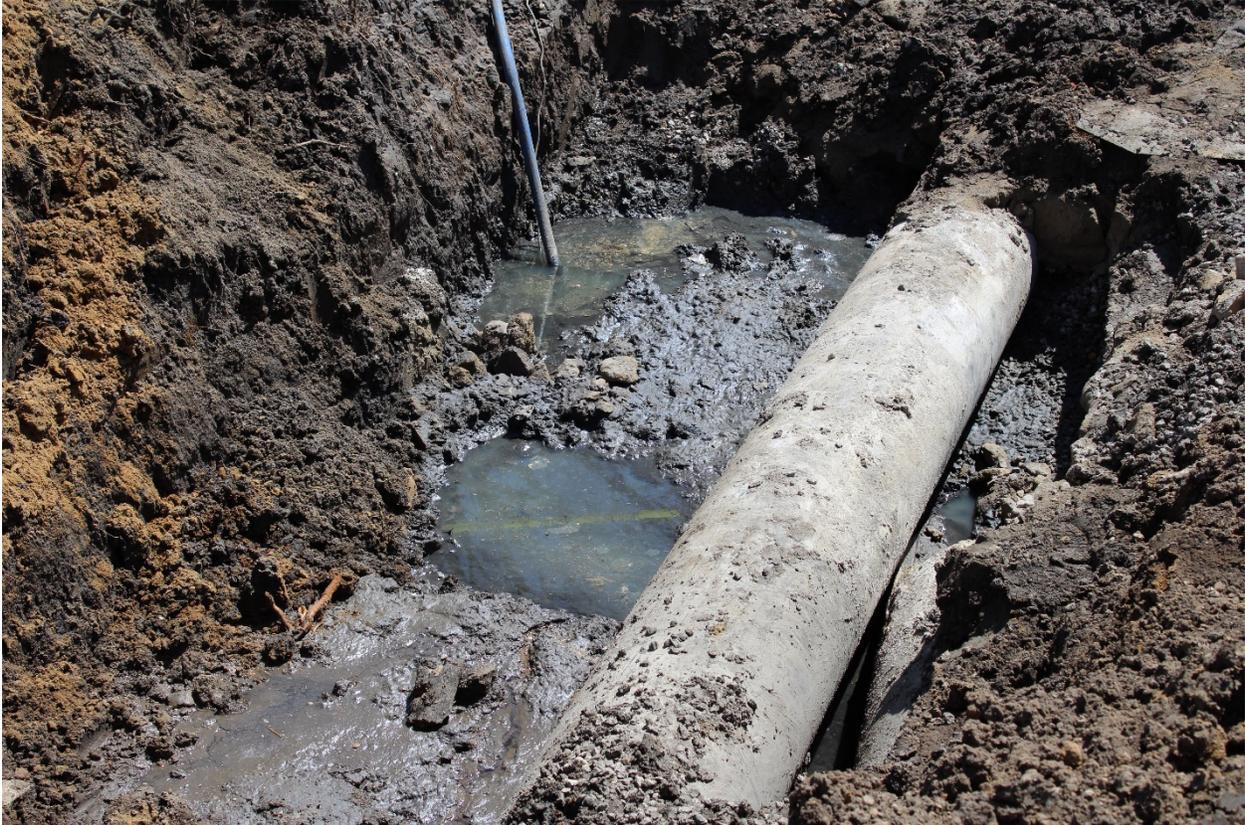
What was thought to be a leak in the new force main from Musser Park to the Water Pollution Control Plant (WPCP) on Tuesday (Apr. 24) turned out to be water leaking from the abandoned 30-inch line (pictured at the right edge of the new line) which was cut apart during the repair process. The new line is working well according to city officials.

“What we found about 7 p.m. last night after we got the area excavated was that the now abandoned 30-inch line had been filling up with water,” Koch said.

Koch noted that there are eight incoming pipes from all over Muscatine that point up and overflow next to each other as they enter the plant. The old 30-inch pipe and the newly installed 24-inch pipe sit next to each other. As the waste water splashes up from the eight incoming pipes, some of that splashing made its way into the presumably empty 30-inch pipe.

“That was enough to fill the 500 feet or so to where we cut the 30-inch pipe last fall to slip in the 24-inch line,” Koch said.

Grout was poured around the end of the abandoned 30-inch pipe as the repair work concluded last February, and it is suspected that the grout shifted with the thaw allowing the water to find a way out.

After chiseling out the grout, the remainder of the old 30-inch main was drained. The City is now looking at how to best cover the 30-inch line so it does not take in water.
